# HOME INSPECTION REPORT

1234 Sample Lane,  
Sampletown, CO. 80555

Prepared for: Ms. Ima Homebuyer

Prepared by: Home Insite Property Inspections  
9358 Shadowglen Ct.  
Highlands Ranch, CO 80126

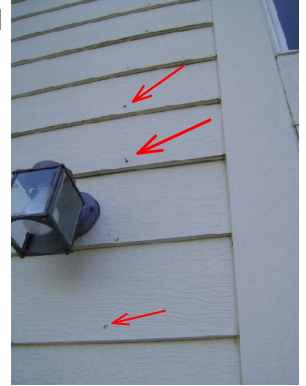
Wood/Composition Siding: Various Areas; Nails are popped or inset too deeply in some areas the siding. This will result in eventual swelling or deterioration around the nail holes due to water infiltration. Re-setting nail pops and filling holes with caulk or spackle prior to re-painting is recommended.

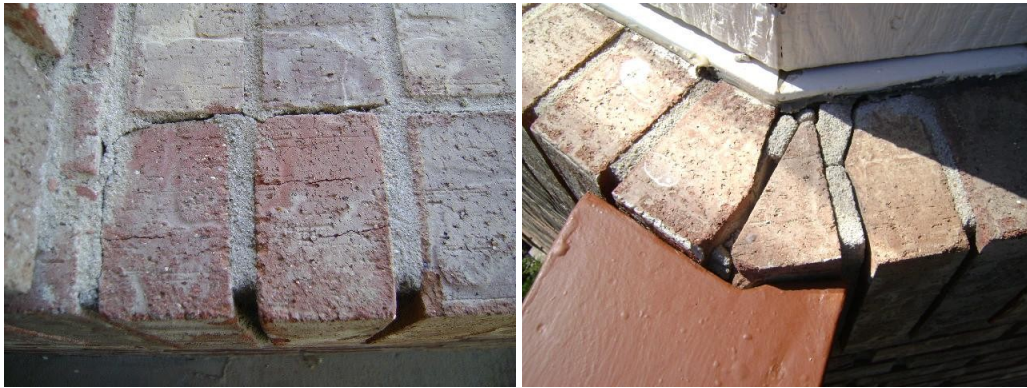
Masonry Siding: Various Areas; Minor repair of cracked or loose brick mortar is needed in several areas.

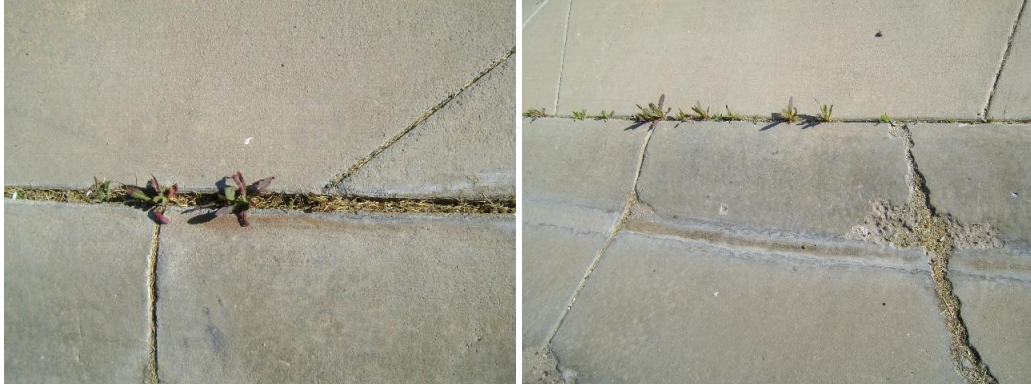
Driveway: Front; Some damaged concrete was noted at the base of the driveway or sidewalk.

Additionally, gaps between concrete sections at the base of the driveway should be sealed with fiberboard expansion strips to prevent water infiltration.

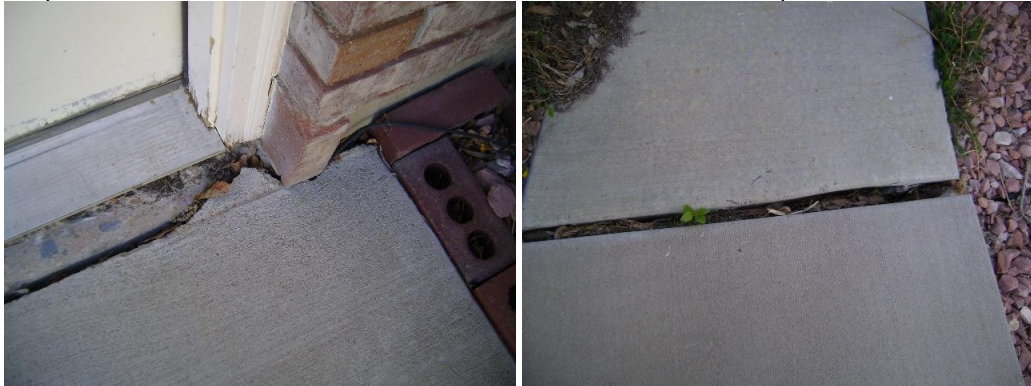
Walks: Front; The concrete is settled or heaved at the side garage entrance. Gaps between concrete sections should be sealed to prevent water infiltration.

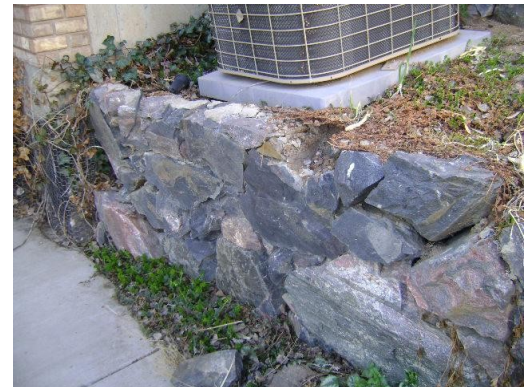
Retaining Walls: West, Stone; The wall is leaning or bowing outward and may be unstable.

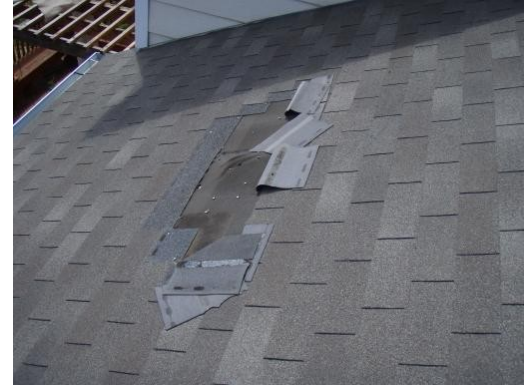
REPAIR                      Roofing: Rear; An area of missing shingles was noted on the rear slope, most likely due to wind damage. A qualified roofer should repair the area.

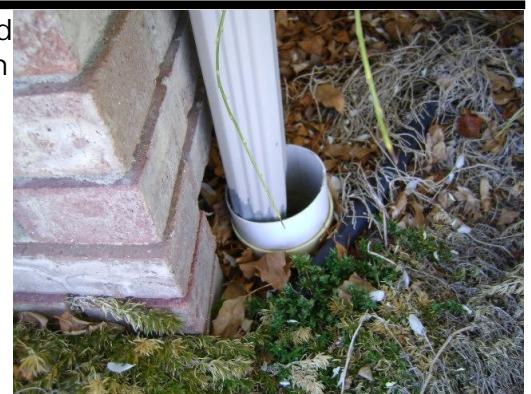
IMPROVE                      Downspouts: Front; A transition fitting needed at the underground drain to prevent debris from clogging the pipe.

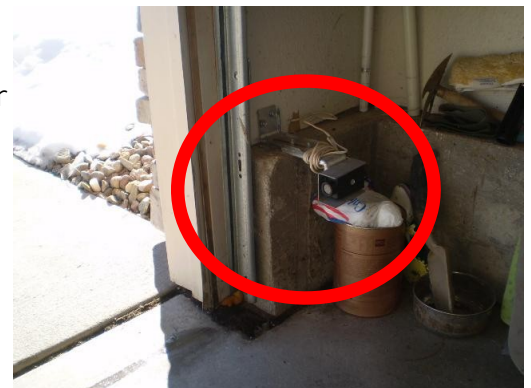
REPAIR                      Garage Door Opener: Photoelectric eyes are installed too high. Photoelectric eyes should be installed no higher than 6 inches off the floor for the safety of children and pets.

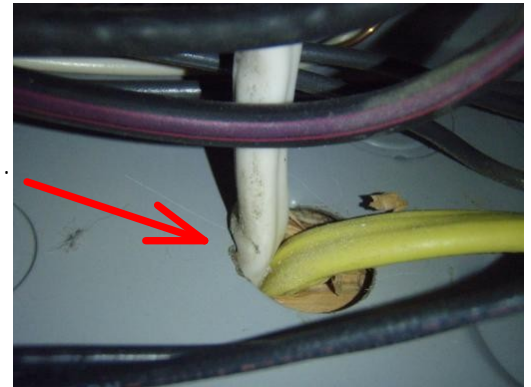
Distribution Panel: Bushings or clamps are missing from the knockout openings where cables enter the panel box. The cables may be damaged by the sharp edges of the openings. Repair by a licensed electrician is recommended.

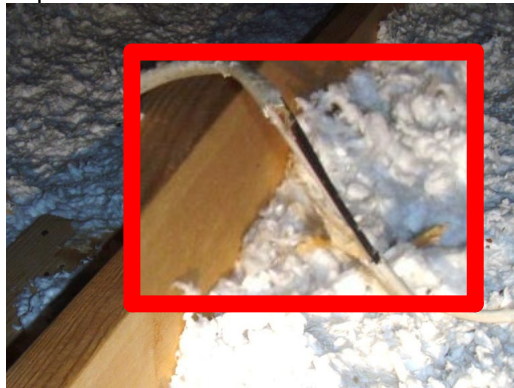
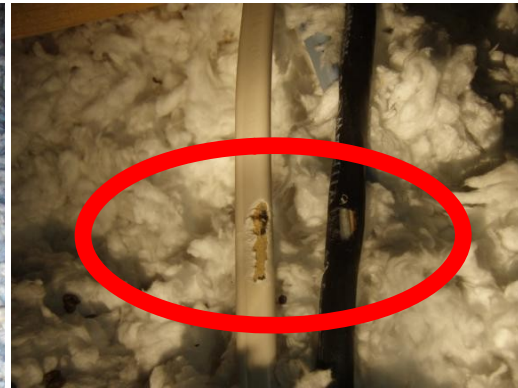
Distribution Wiring: Attic; Several electrical cables are damaged in a manner consistent with rodent activity. The cable jacket has been chewed off in several areas. A licensed electrician should fully evaluate all the attic wiring and repair or replace as needed. An exterminator should be contacted to rid the attic of rodents.

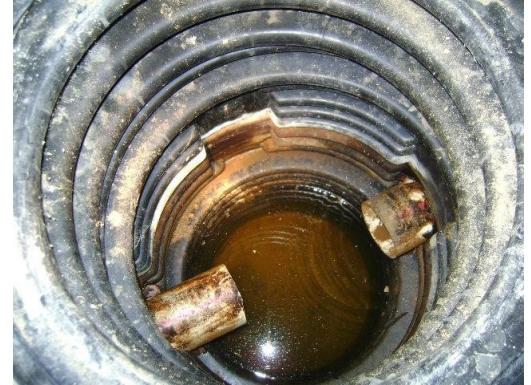
Sump Pump: No sump pump is currently installed. As water was present in the sump pit, it is recommended that a pump and discharge line be installed.

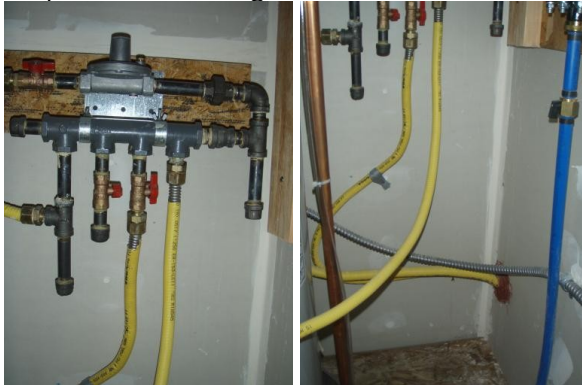
Gas Pipes: No bonding/ grounding wire was found to the natural gas piping in the home. CSST gas piping must be properly bonded/grounded to the electrical grounding electrode, typically using a #6 copper wire at the point where the piping first enters the home. This type of piping may rupture causing a gas leak and possible explosion or fire if lightning strikes in the area of the home. A licensed electrician should properly bond/ground the gas piping to manufacturers specifications, which can be found on page 68 of the PDF file on the web at: [http://www.omegaflex.com/trac/technical/Omegaflex\\_DI\\_Guide.pdf](http://www.omegaflex.com/trac/technical/Omegaflex_DI_Guide.pdf)

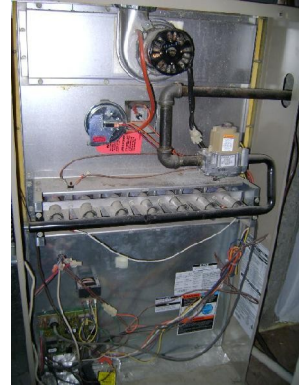
Furnace: The furnace responded properly to operating controls, and is in overall good and functional condition.

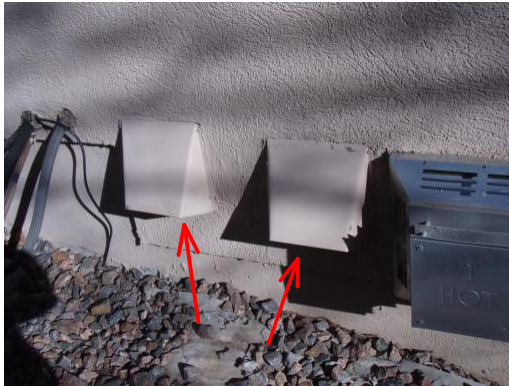
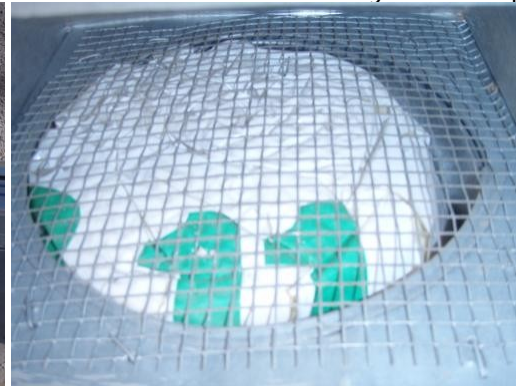
Combustion Air: Vent pipes from exterior; The combustion air intakes on the exterior wall have been blocked off. The air intakes should be cleared of obstruction to insure a proper supply of combustion and makeup air to the furnace and water heater. Lack of combustion air may cause backdrafting of noxious exhaust fumes into the home, or result in lessened efficiency of the appliances.

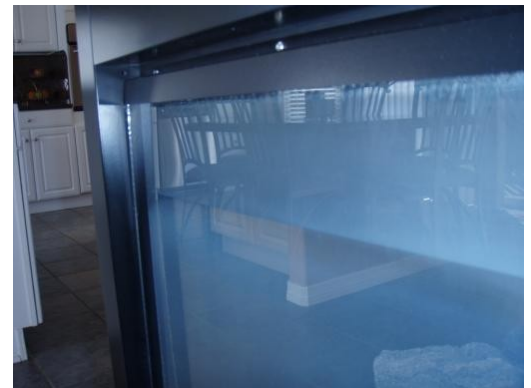
Fireplace: Family Room; Fogging on fireplace glass may indicate a poor seal or drafting problems. The fireplace should be serviced and repaired as needed by a qualified gas fireplace contractor.

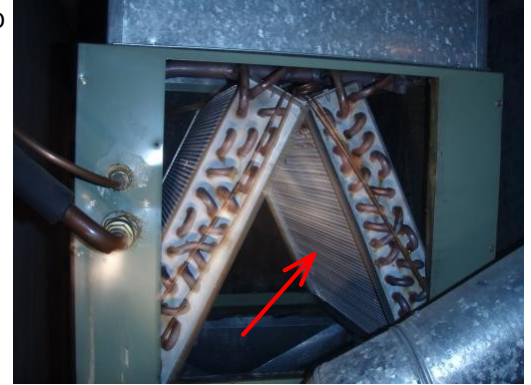
Air Conditioning: Responded properly to operating controls.  
Temperature Drop: Measured temperature drop is in the normal range.  
Evaporator Coil: Coil fins are dirty and need to be cleaned.

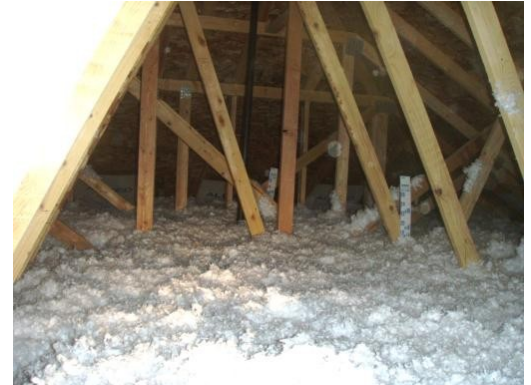
Location: Main Method of Inspection: Entered but access was limited  
Attic/Roof Insulation: Loose fiberglass Thickness: 10-12 inches  
Attic/Roof Ventilation: Roof Vents, Soffit Vents  
General Comment: Visible attic insulation and ventilation levels are good and consistent with current standards. No improvements appear to be needed at this time.

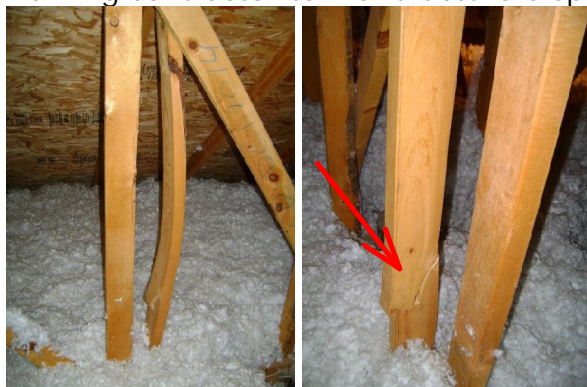
REPAIR                      Roof Framing: Attic; Two split and warped roof truss members were visible from the attic area. The weakened trusses may not support heavy snow loads, and may be prone to deteriorate further. The members should be repaired by a qualified framing contractor to manufacturers specifications.

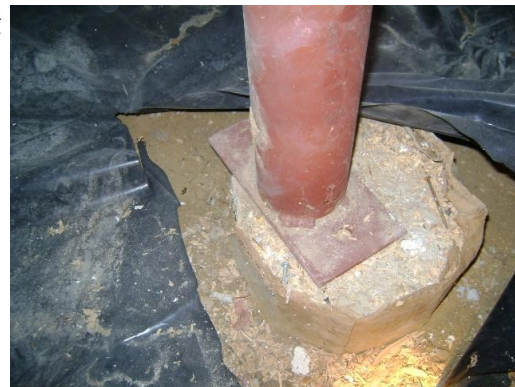
REPAIR                      Piers/Posts: Crawlspace; The steel post is not attached at the base. The post should be bolted to the concrete footing as a preventative measure against possible movement.

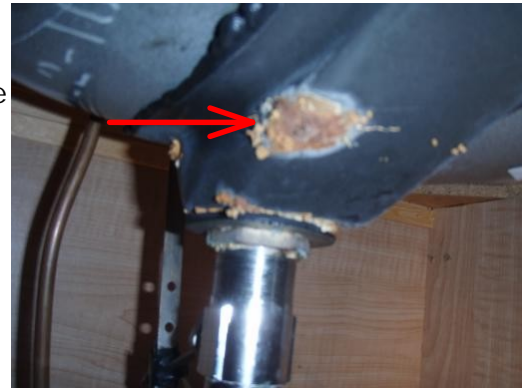
REPAIR Sink/Basin: Master Bathroom; The overflow channel and drain connection on the underside of the sink are heavily rusted and may leak. The sink will need to be replaced.

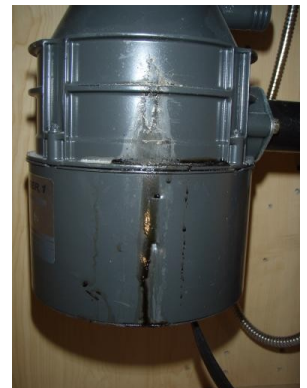
SATISFACTORY Range: Jen-aire  
IMPROVE Disposal: 1/2 HP; Leaking from housing. Inoperative- failed to respond to operating controls. Replacement is recommended.
